NATIONAL TRANSPORTATION SAFETY BOARD

HIGHWAY ACCIDENT REPORT

MULTIPLE-VEHICLE COLLISIONS AND FIRE
DURING LIMITED VISIBILITY (FOG)
ON INTERSTATE 75 NEAR CALHOUN, TENNESSEE
DECEMBER 11, 1990

Abstract: About 9:10 a.m. on December 11, 1990, during fog on Interstate 75 near Calhoun, Tennessee, 99 vehicles were in multiple-vehicle chain-reaction collisions that killed 12 people and injured 42 others.

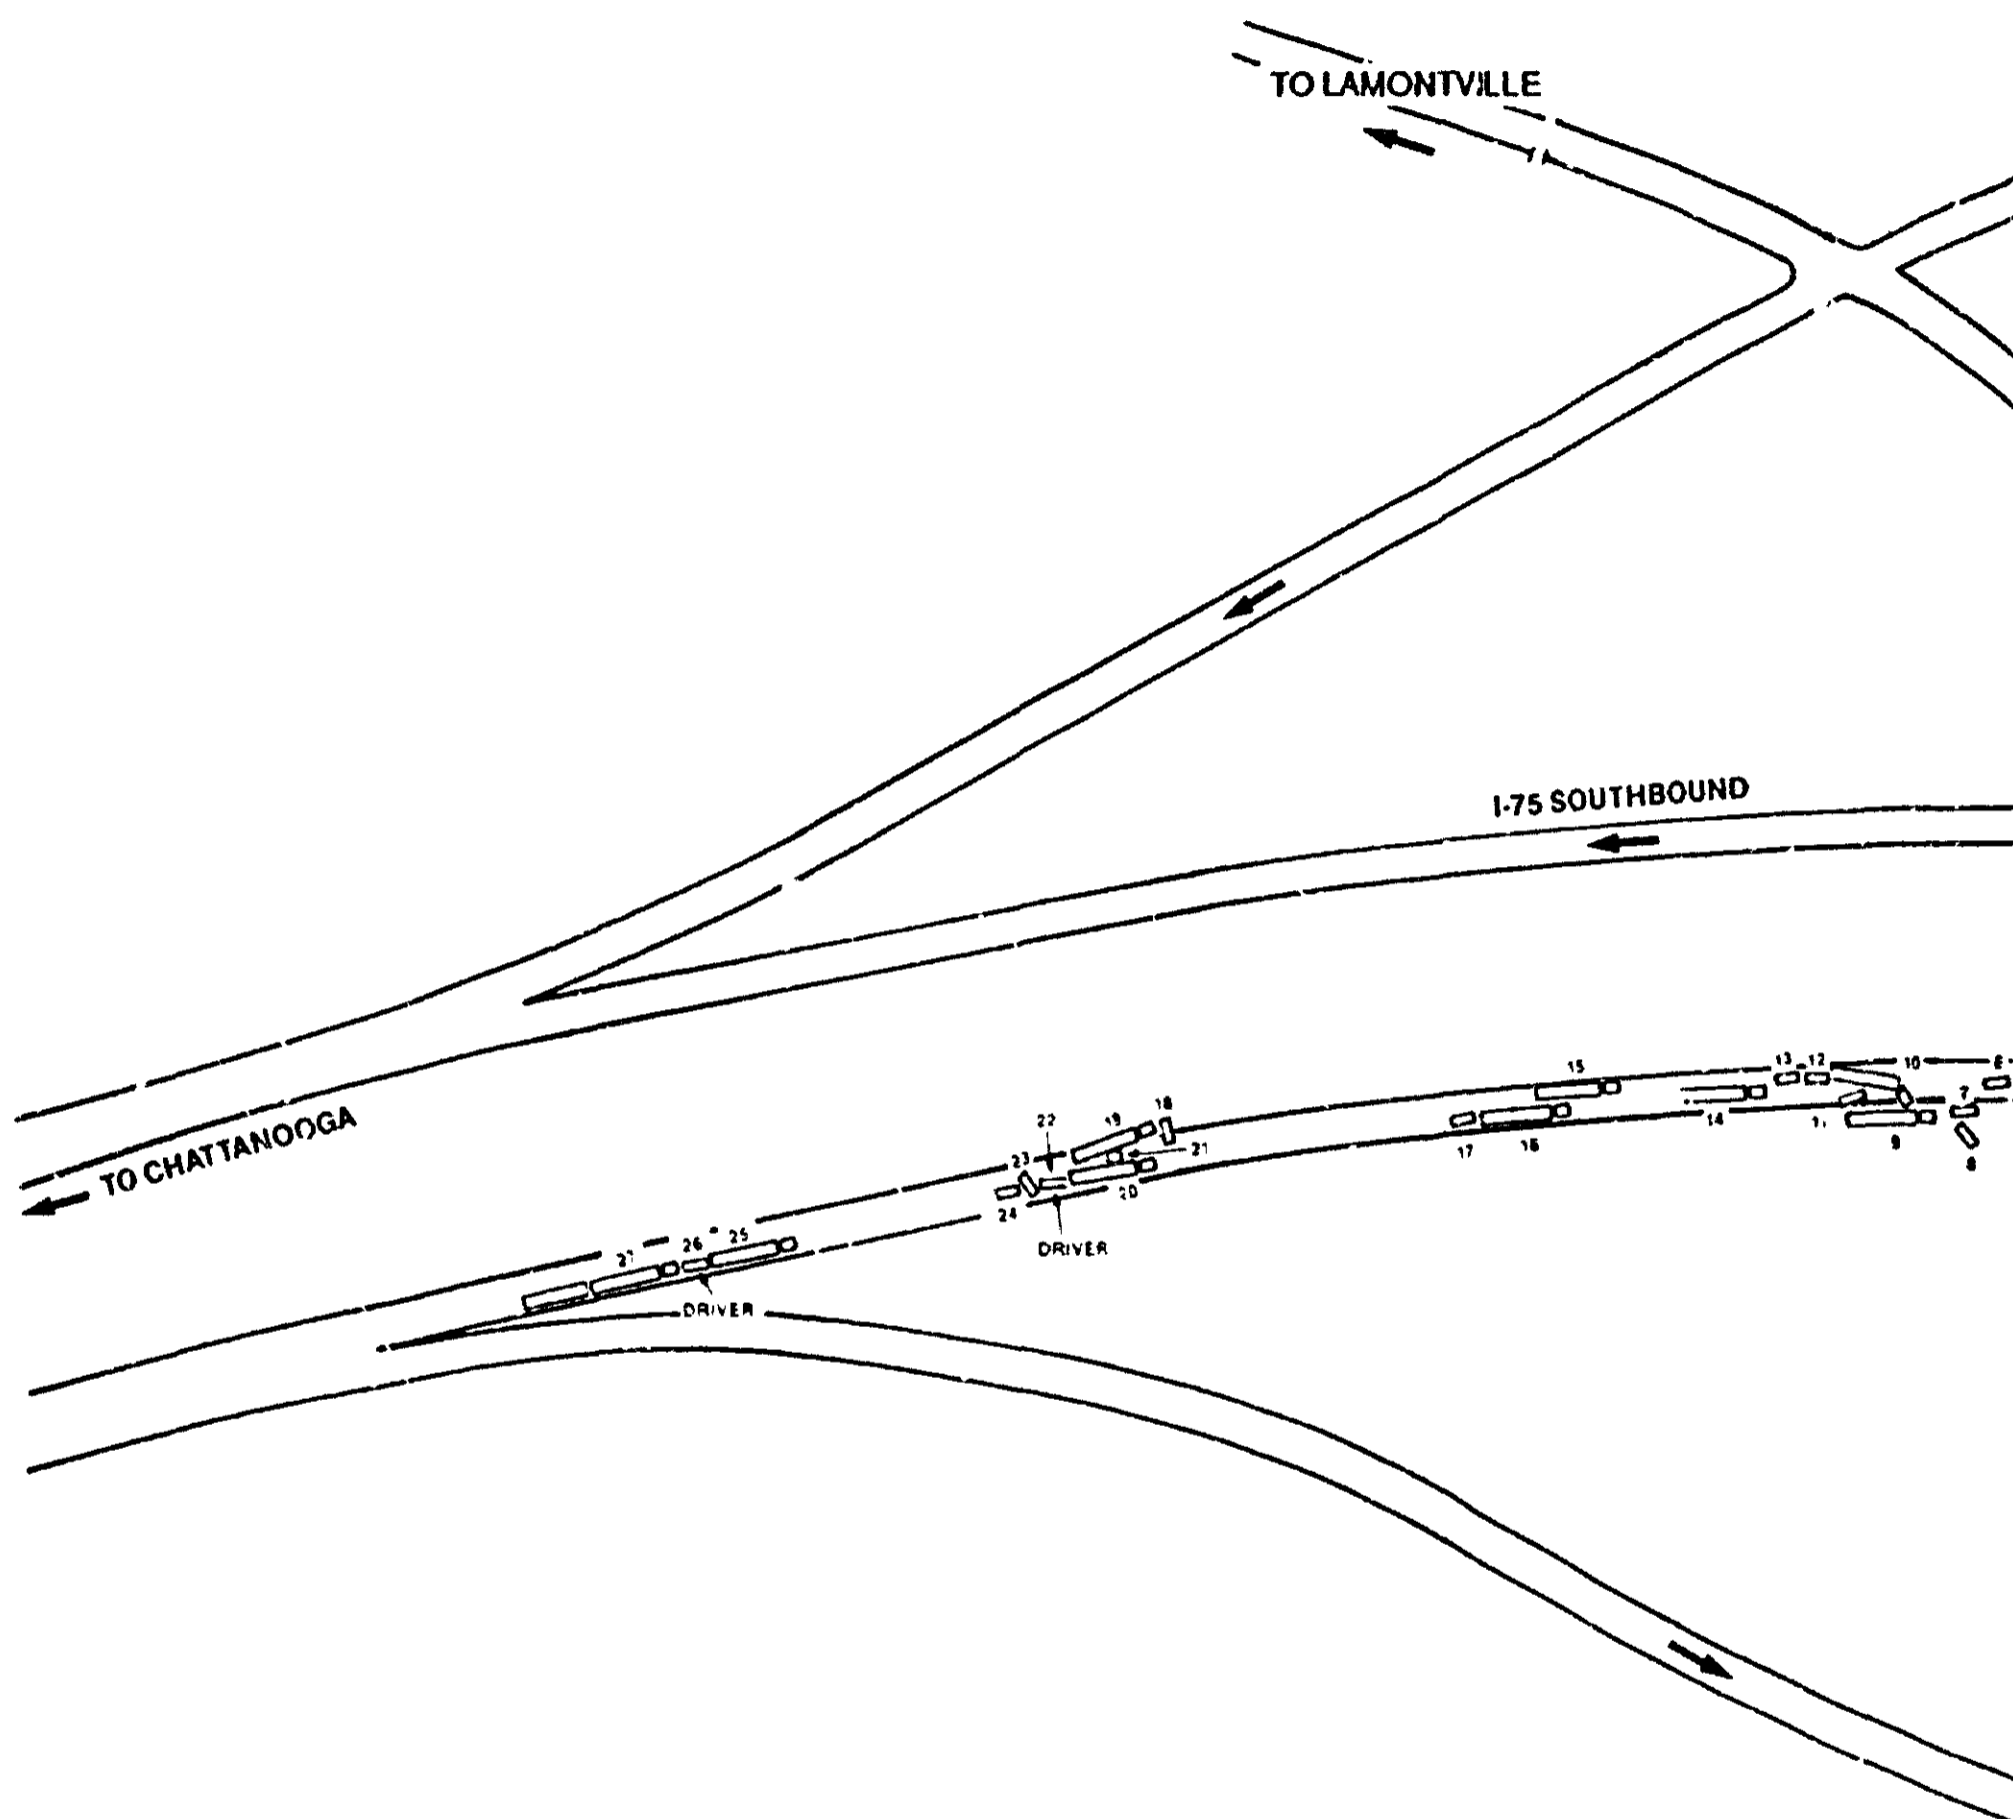
Figure 3. Postaccident location of vehicles.

Because cleanup operations and reopening the highway prevented the Safety Board from reconstructing the accident, investigators used police reports, witness statements, videotapes, and aerial photographs to develop the accident scenarios. (See figure 3 and appendix C.)

Not to Scale. Vehicles in relative positions.
 Not all vehicles shown on diagram; appendix C
 lists vehicles shown. Fatally injured persons are
 also indicated.
